**Stop Making
Your Pumps
an Annuity for
Repair Companies
& Shipyards**

SIMS PUMP VALVE COMPANY • SINCE 1919

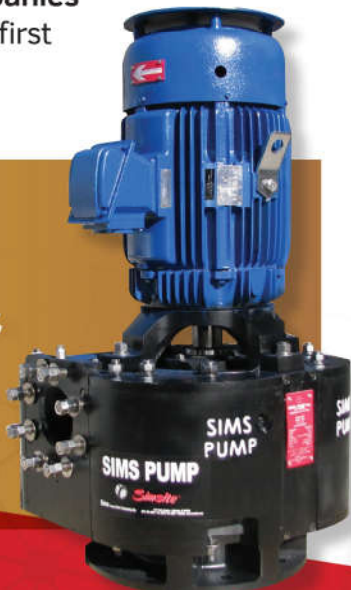
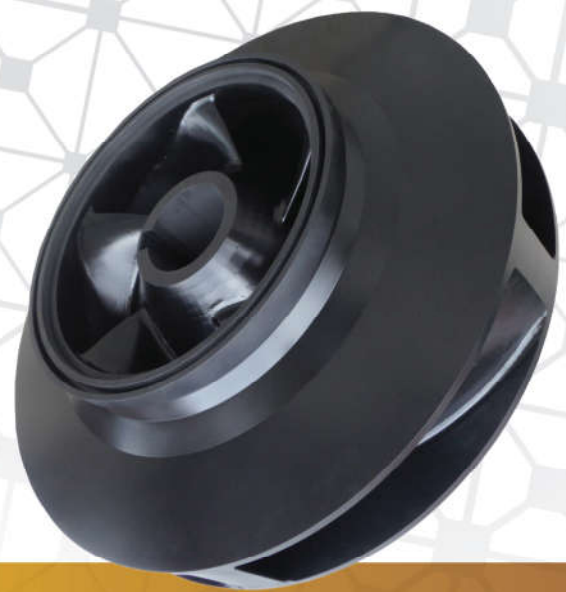
SIMSITE® Structural Composite Pumps NEVER CORRODE in Seawater, Wastewater, Sewage, River Water, Chlorinated Water and are Excellent with most chemicals.

SIMSITE® Impellers & Rings are Energy Efficient, Light Weight, Perfectly Balanced (and remain perfectly balanced for the life of the pump), DO NOT CORRODE, and DO NOT Support Electrolysis!

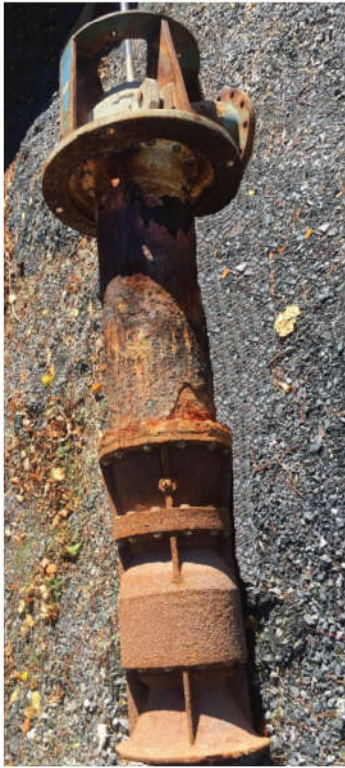
(f) Erosion-corrosion.—The accelerated metal loss from an initial corrosion mechanism associated with high-velocity flows and abrasion. Erosion-corrosion is caused by the relative movement between a corrosive fluid and a metal surface. This process leads to the formation of grooves, gullies, valleys, rounded ridges, wavy surfaces, holes, etc., and exhibits a directional flow pattern. (Comet tails, horseshoe marks, etc.)

In two-phase liquids (containing suspended solid particles, solids, or gas bubbles), the impact of the particles damages, or even eliminates the protective layers, passive films, or protective coatings causing the local corrosion rate to be markedly accelerated. This phenomenon is called abrasion-corrosion.

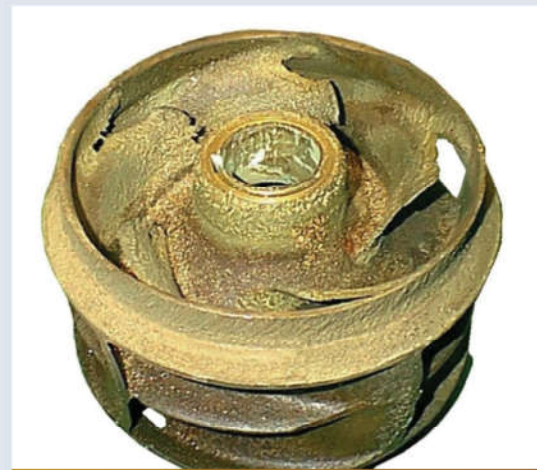
*Metallic Impellers & Rings like the Impeller above are subject to Corrosion, Erosion, Electrolysis, and Cavitation, which is NOT the case with **SIMSITE®** Impellers & Rings!*

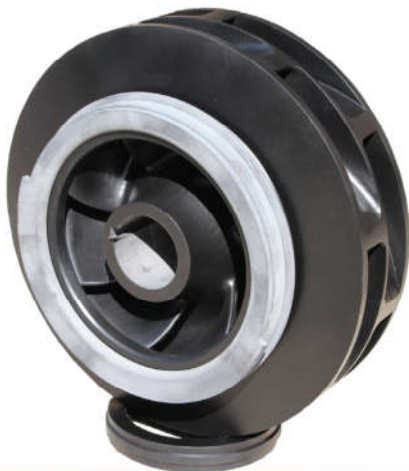
SIMSITE® Structural Composite Horizontal Double Suction Pump which is more Energy Efficient and is NOT subject to Electrolysis, Corrosion, or Cavitation Problems!

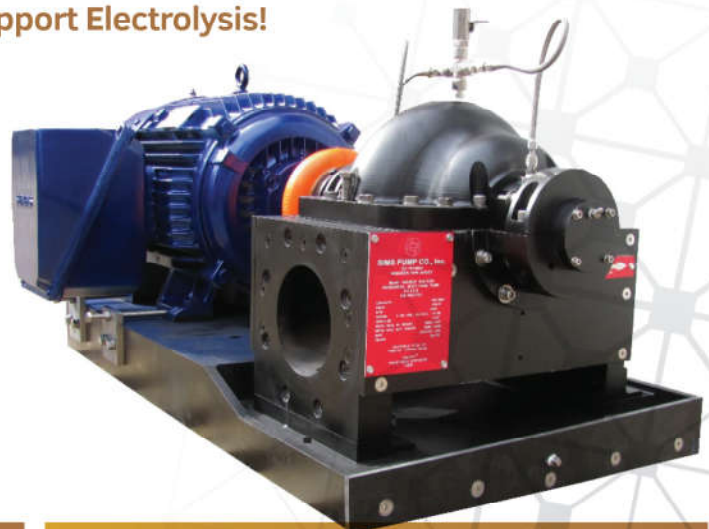
SIMSITE® Impellers & Rings are Inert and NOT subject to Electrolysis or Corrosion. They are 100% machined on the Inside as well as the outside.

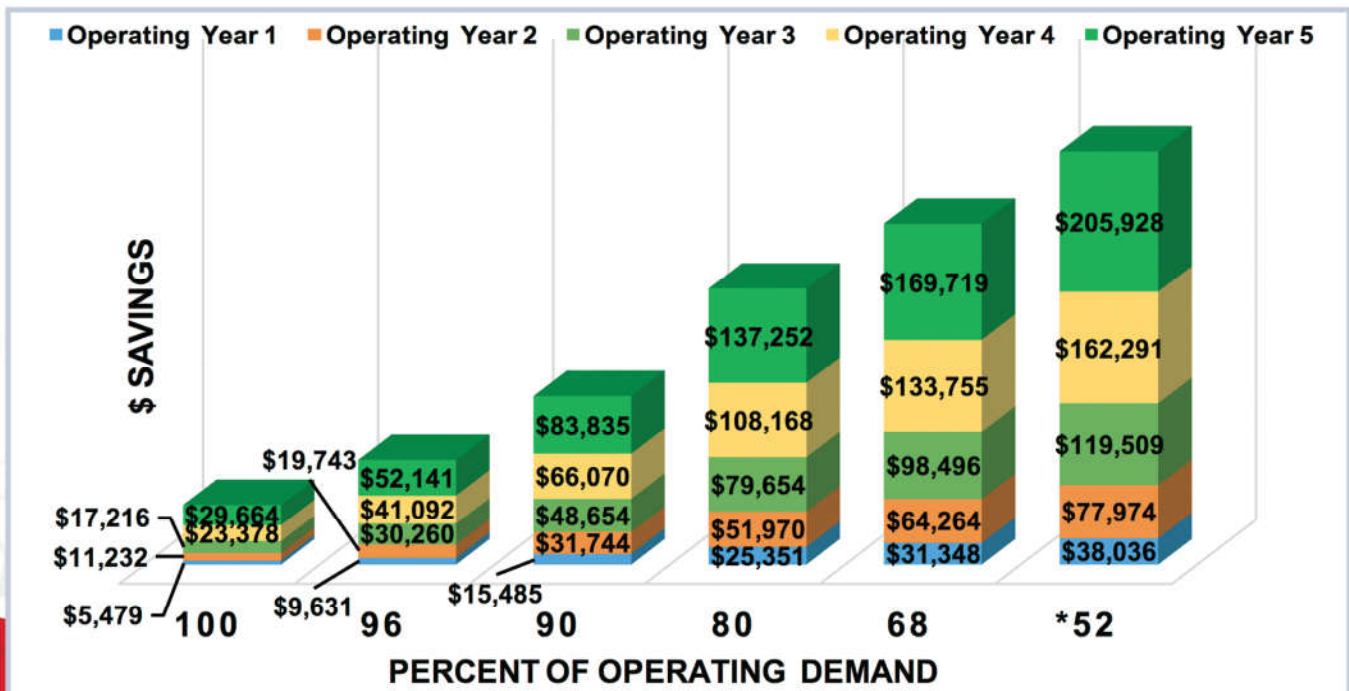
**\$ ENERGY SAVINGS USING
SIMSITE® IMPELLERS & RINGS AND VFD**

Analysis of Savings As a Result of Increasing Efficiency with the installation of **SIMSITE®** Impellers & Casing Rings with a VFD system:

**ENERGY SAVINGS – VFD
WITH SIMSITE® IMPELLERS & RINGS**

Oper Dem	VFD Eff	Eff w/ Mtal 1 yr	Eff w/ Mtal 2 yr	Eff w/ SIM®	Eff w/ SIM® & Vfd	BHP w/ Vfd & SIM	kW Sav	Cap m3/h	Hd M	RPM	Sav/yr1 w/ SIM® & Vfd	Sav/yr2 w/ SIM® & Vfd
100	98	75	70	85	83.3	50.9	5.3	600	19	1750	\$5,479	\$5,753
96	97	75	70	85	82.5	45.5	9.3	576	18	1680	\$9,631	\$10,112
90	96	75	69	85	81.6	37.9	15.0	540	15	1575	\$15,485	\$16,259
80	94	75	68	85	79.9	25.0	24.6	480	11	1400	\$25,351	\$26,619
68	91	75	67	85	77.4	17.2	30.4	408	9	1190	\$31,348	\$32,916
*52	80	70	65	85	68.0	8.5	36.9	260	6	908	\$38,036	\$39,938

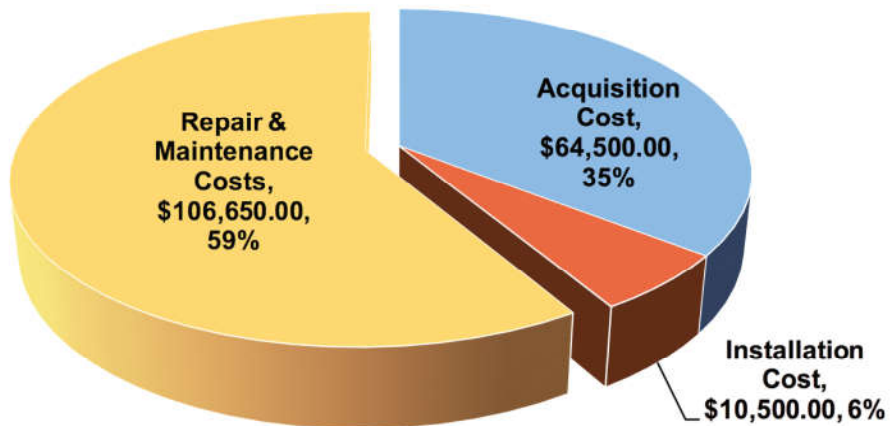
LIFE CYCLE EXPENSES FOR MAIN ENGINE SALT WATER COOLING PUMP / 5 YEARS WITH A STAINLESS STEEL IMPELLER

ESTIMATED OPERATING AND MAINTENANCE COSTS WITH THE STAINLESS STEEL IMPELLER AND BRONZE CASING RINGS:

Cost of Pump.....	\$64,500
Est. Life of Bronze Casing Rings	6 - 8 months
Est. Life of Ball Bearings under these conditions.....	6 - 8 months
Est. Life of Mechanical Seal under these conditions.....	6 - 8 months
Est. Cost to Overhaul pump with new Rings, Bearings, Seals, & Gaskets.....	\$12,500/yr
Est. Life of Stainless Steel Impeller.....	3 years
Est. Cost of Stainless Steel Impeller 11.26 x 5.00-S.....	\$ 8,500
Period that the Pump Casing will need repair	3 years
Est. Cost to Overhaul Pump Casing	\$18,000
Total Expenses for Repair & Maintenance over a 5 year period with Stainless Steel Impeller and bronze Casing Rings	\$106,650
