Simsite ® Structural Composite Pumps.

NAVY STANDARD COMPOSITE Pumps

Test Results

Medium Weight Shock and Vibration Test Report
on
1 ½” x 1” x 8 20 HP NS 16486-2SA20 Pump
for
Sims Pump Valve Company
Hoboken, NJ

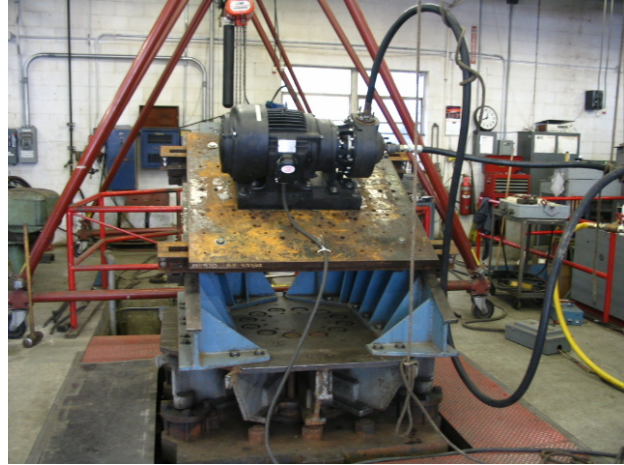
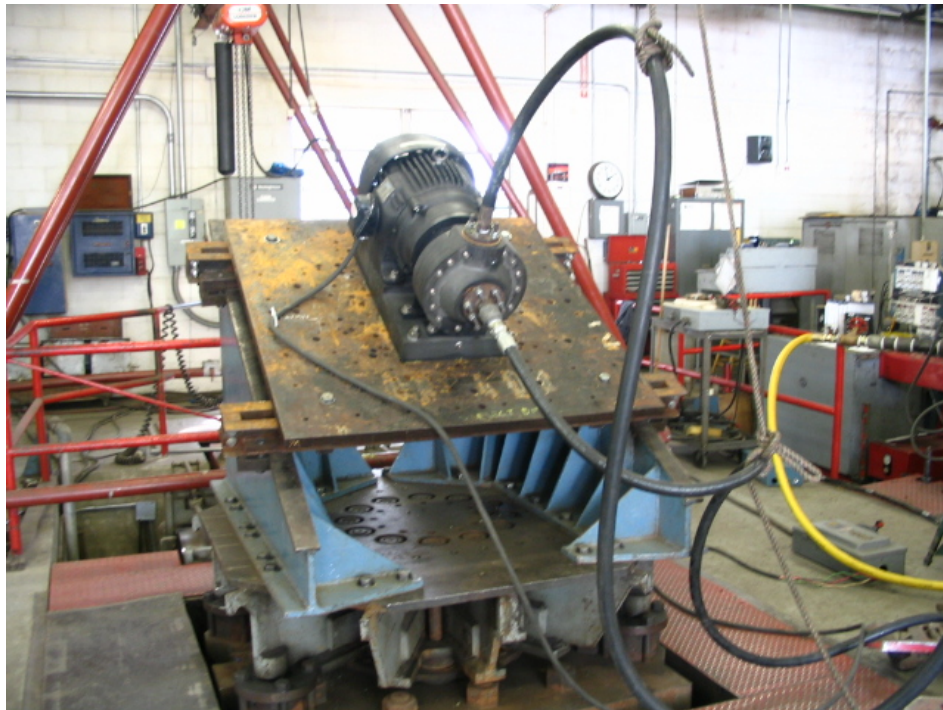
**Shock Test Setup Photographs
Figure 1**

The Pump was attached to a 48" x 48" x 1 1/2" steel plate using four (4) 7/8"-8 Grade 5 bolts torqued to 150 lbs-ft. The entire assembly was then secured to fixture Figure 13 of MIL-S-901D on the medium weight shock machine orientated in the first major axis of test. A 17.6 pound dummy mass was attached to the suction side of the Pump using six (6) 1/2"-13 B7 threaded rod, nuts and washers torqued to 45 lbs-ft. A 10 pound dummy mass was attached to the discharge side of the Pump using four (4) 1/2"-13 B7 threaded rod,, washers, and nuts torqued to 45 lbs-ft. The total weight on the anvil table was found to be 2,128.5 pounds. Refer to Table 1 for the medium weight shock test weights and Figure 1 for photographs of the test setup.

The entire assembly was then removed from fixture Figure 13 of MIL-S-901D, and reattached to fixture Figure 16 of MIL-S-901D of the referenced specifications, orientated with the side of the Pump facing down. The total weight on the anvil table was found to be 3,218.5 pounds. Refer to Figure 1 for a photograph of the test setup and Table 1 for a breakdown of the test weights.

The entire assembly was removed from fixture Figure 16 of MIL-S-901D, rotated 90° and reattached to MIL-S-901D Figure 16 with the suction side of the Pump facing down; see Figure 1. The total weight on the anvil table remained at 3,218.5 pounds.

Vertical Axis

Pump Shaft Perpendicular to Incline Axis

Pump Shaft Parallel to Incline

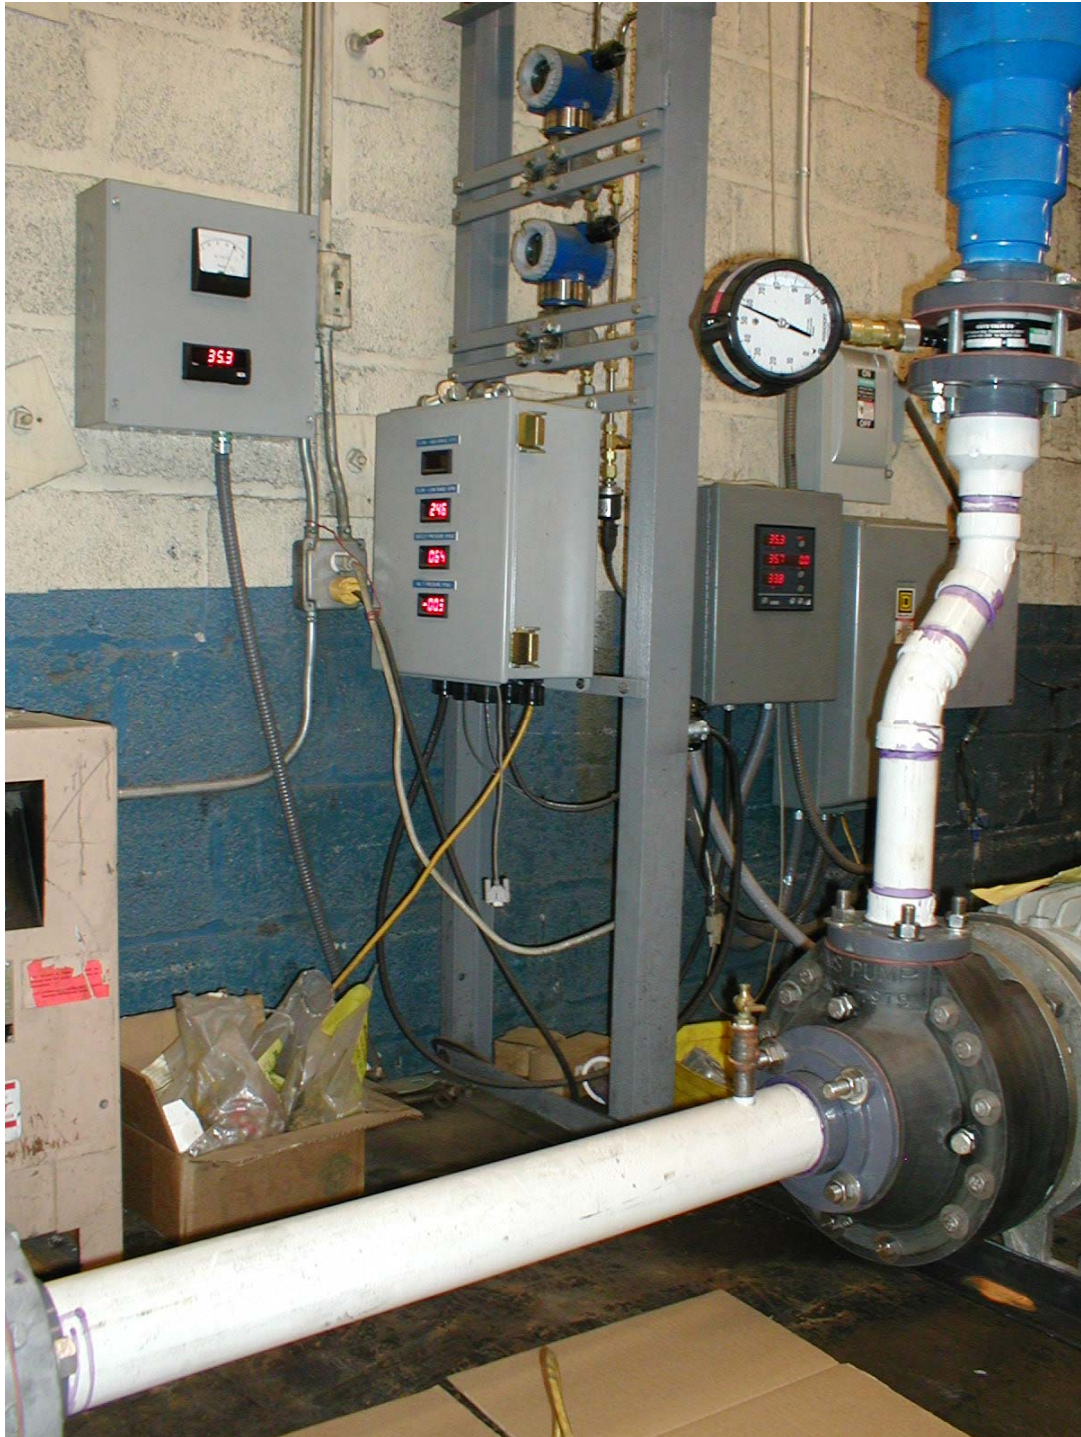
Figure 1. Pump on the Test Stand.

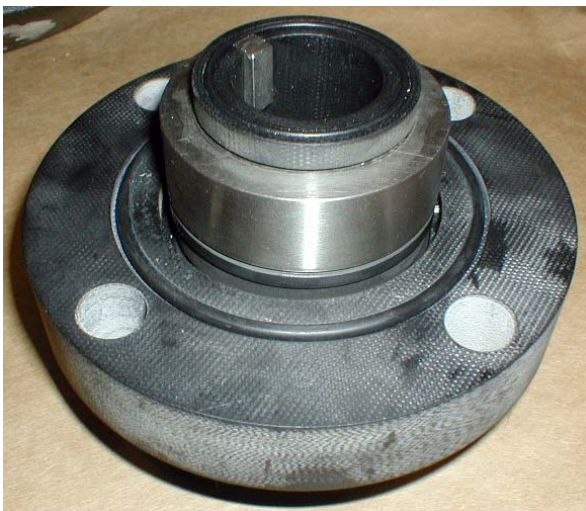
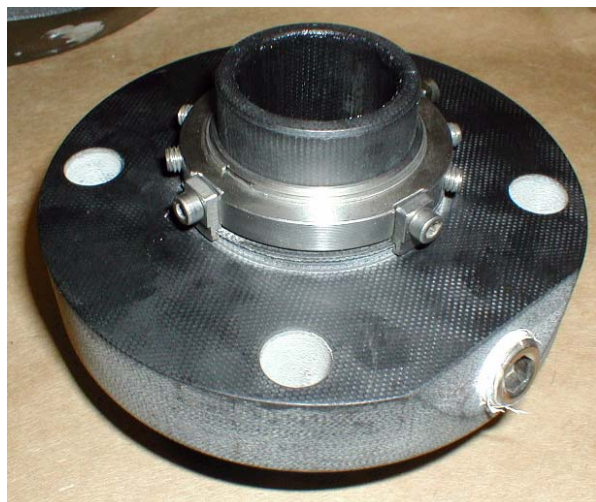
The SIMSITE Cartridge Mechanical Seal provides the following benefits when compared with standard spring loaded seals:

1. The Cartridge Seal is more reliable.
2. The Cartridge Seal is easier to install and maintain.
3. The Cartridge Seal can be inspected with out pump disassembly.
4. SIMSITE Cartridge Seals are self aligning on the shaft, and therefore do not require installation fixtures.
5. The Seal Gland and Sleeve components are made from SIMSITE Structural Composite and therefore will not corrode in seawater.

SIMSITE Structural Composite Cartridge Mechanical Seal, offers superior design and performance when compared with a standard spring loaded seal.

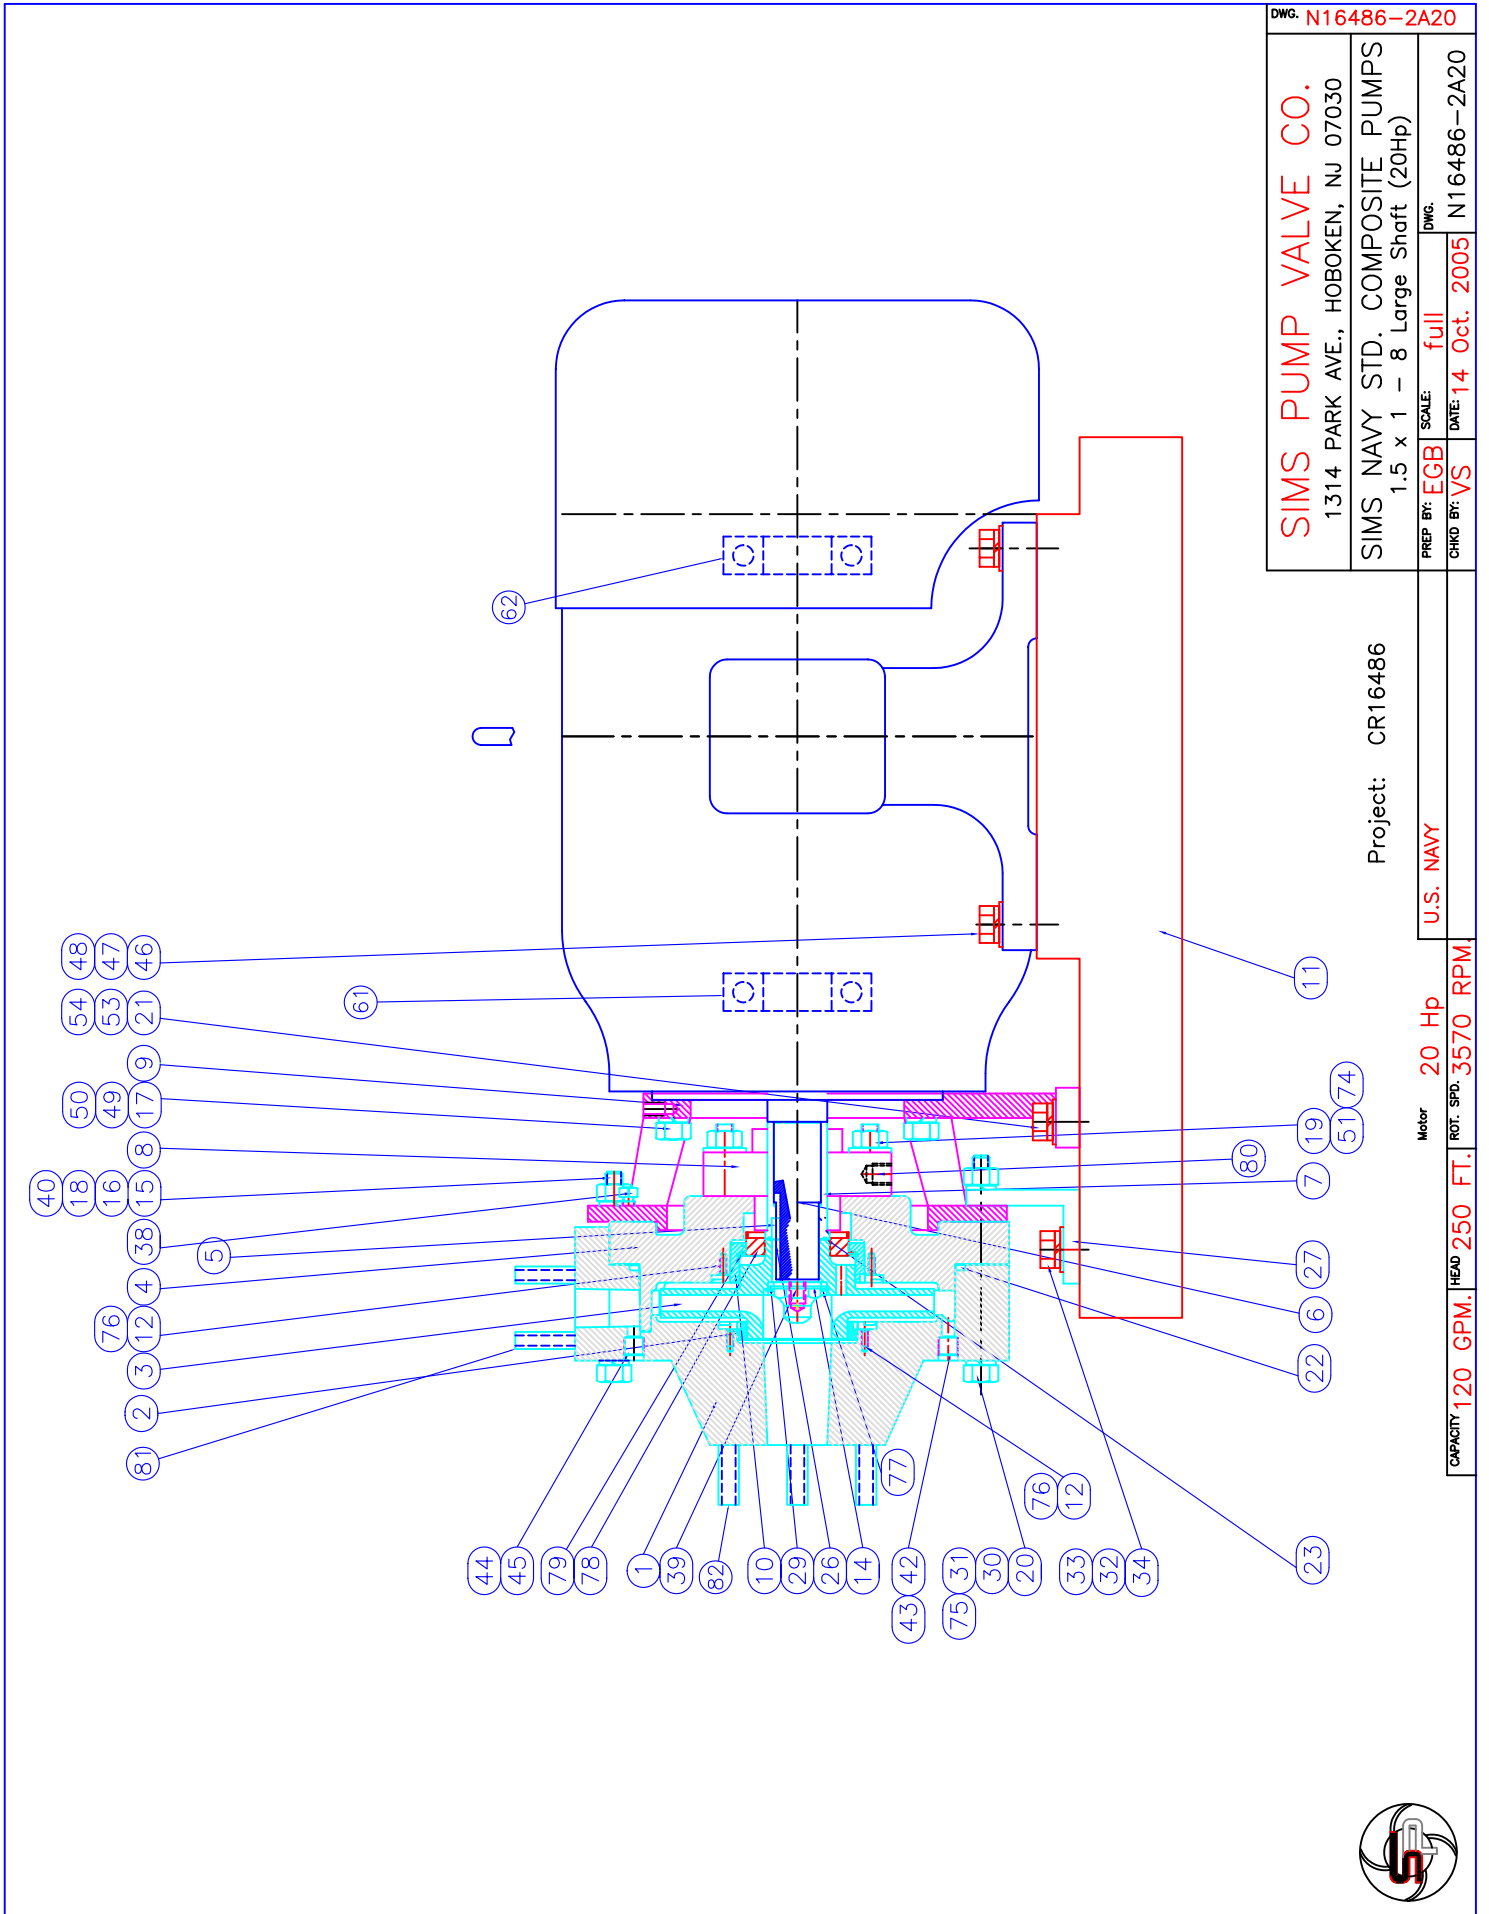
14. Cross Section (Detail)

DWG. N16486-2A20	
SIMS PUMP VALVE CO.	
1314 PARK AVE., HOBOKEN, NJ 07030	
SIMS NAVY STD. COMPOSITE PUMPS	
1.5 x 1 - 8 Large Shaft (20Hp)	
PREP BY: EGB	DWG. SCALE: full
CHKD BY: VS	DATE: 14 Oct. 2005
N16486-2A20
