**Medium Weight Shock and Vibration
Test Report
on
3x2x6 Composite Pump
for
Sims Pump Valve Company, Inc.
Hoboken, NJ**

NU LABORATORIES, INC.

29 December 2003

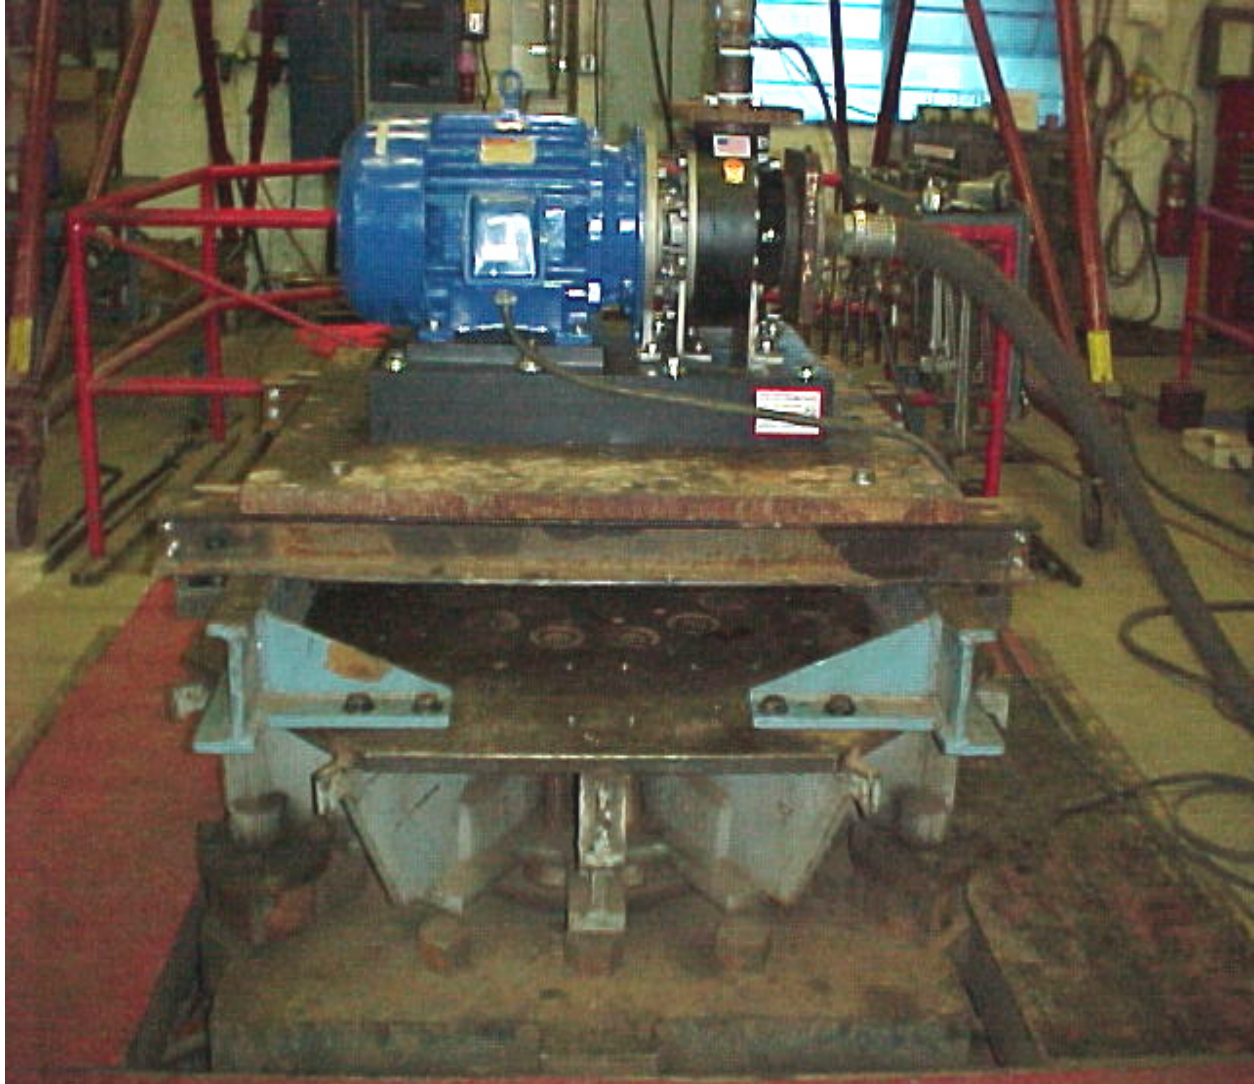
**Vertical Shock Test Setup
Figure 1**

The Pump was attached to the test fixture using eight (8) 7/8"-9 Grade 5 bolts torqued to 400 ft-lbs. The entire assembly was then secured to fixture Figure 13 of MIL-S-901D on the medium weight shock machine, see Figure 1. The total weight on the anvil table was found to be 2,383 pounds.

- 12.1.1 Conditions: 1.25' hammer height, Group #I, 3" anvil table travel, Figure 13 of the referenced specifications.
- 12.1.2 Observations: A post-blow visual inspection revealed no obvious physical damage.
- 12.1.3 Action: Testing was continued.

- 12.2.1 Conditions: 2.25' hammer height, Group #II, 3" anvil table travel, Figure 13 of the referenced specifications.
- 12.2.2 Observations: A post-blow visual inspection revealed no obvious physical damage.
- 12.2.3 Action: Testing was continued.

- 12.3.1 Conditions: 2.25' hammer height, Group #III, 1.5" anvil table travel, Figure 13 of the referenced specifications.
- 12.3.2 Observations: A post-blow visual revealed no obvious physical damage.
- 12.3.3 Action: Testing was continued.

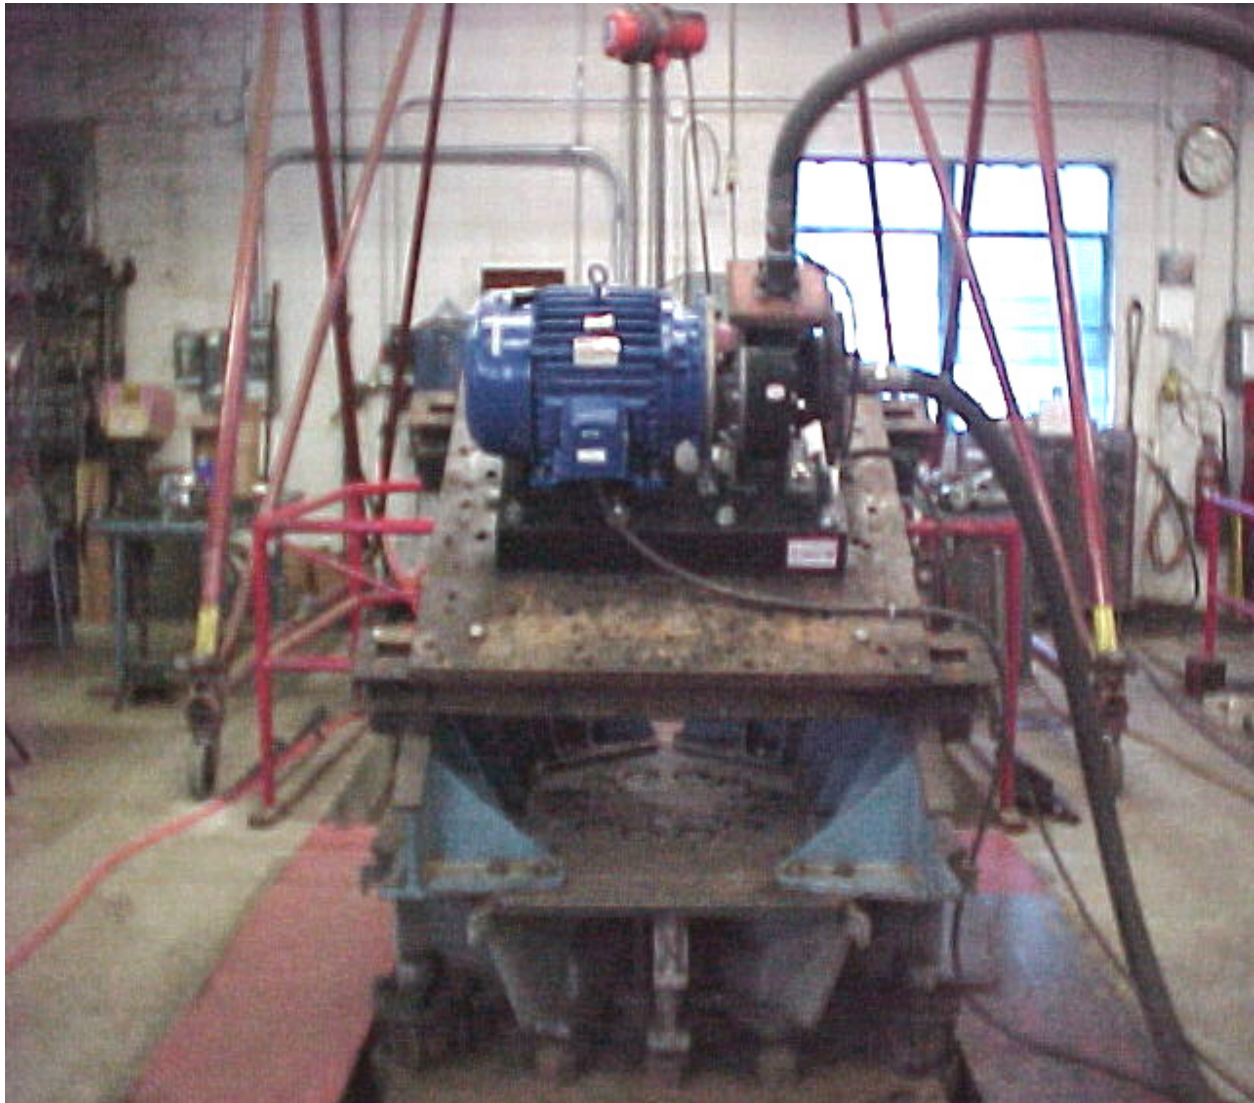
**Pump Shaft Perpendicular to Incline Shock Test Setup
Figure 2**

The entire assembly was removed from fixture Figure 13 and attached to fixture Figure 16 of MIL-S-901D with pump shaft perpendicular to the incline, see Figure 2. The total weight on the anvil table was found to be 3,473 pounds.

- 12.4.1 Conditions: 1.5' hammer height, Group #I, 3" anvil table travel, Figure 16 of the referenced specifications.
- 12.4.2 Observations: A post-blow visual inspection revealed no obvious physical damage.
- 12.4.3 Action: Testing was continued.

- 12.5.1 Conditions: 2.5' hammer height, Group #II, 3" anvil table travel, Figure 16 of the referenced specifications.
- 12.5.2 Observations: A post-blow visual inspection revealed no obvious physical damage.
- 12.5.3 Action: Testing was continued.

- 12.6.1 Conditions: 2.5' hammer height, Group #III, 1.5" anvil table travel, Figure 16 of the referenced specifications.
- 12.6.2 Observations: A post-blow visual inspection revealed no obvious physical damage.
- 12.6.3 Action: Testing was continued.

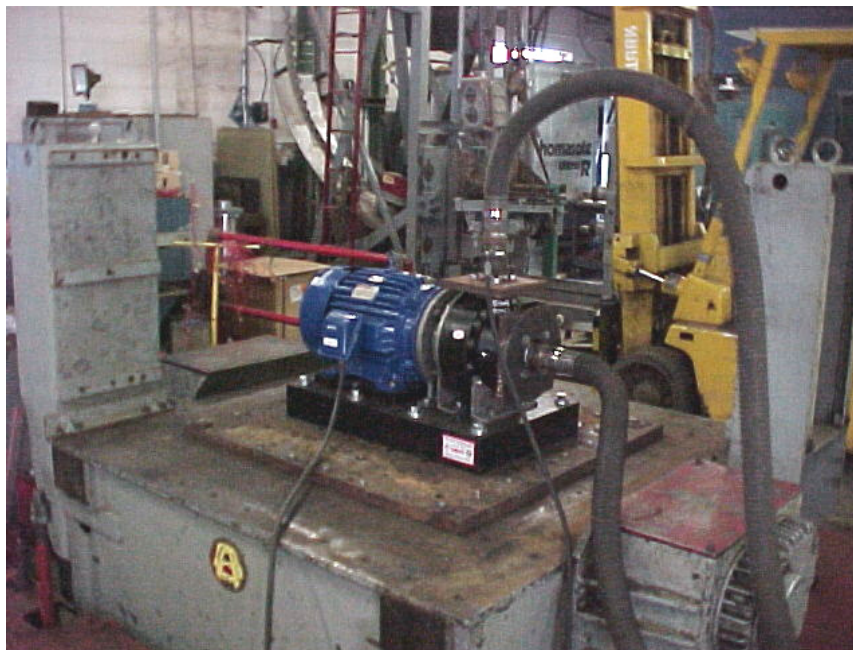
**Vibration Test Setup
Figure 7**

The Pump was removed from the medium weight shock machine and attached to the vibration machine orientated in the first major axis of test, see Figure 7.

An accelerometer was attached to the Pump to aid in the detection of response prominences.

End to End and Vertical Axes

Side to Side Axis

The vibration test was performed from 4 Hz to 50 Hz in each of the three (3) major axes.

The Pump was energized and operating with 440 VAC, three (3) phase, 60 Hz power and the discharge pressure adjusted to 60 psig throughout the vibration test.
