Why Coatings Are Not The Best Solution for Rotating Equipment

Structural
Composite
Impellers,
Casing Rings, and
Pumps are a
Much Better Solution

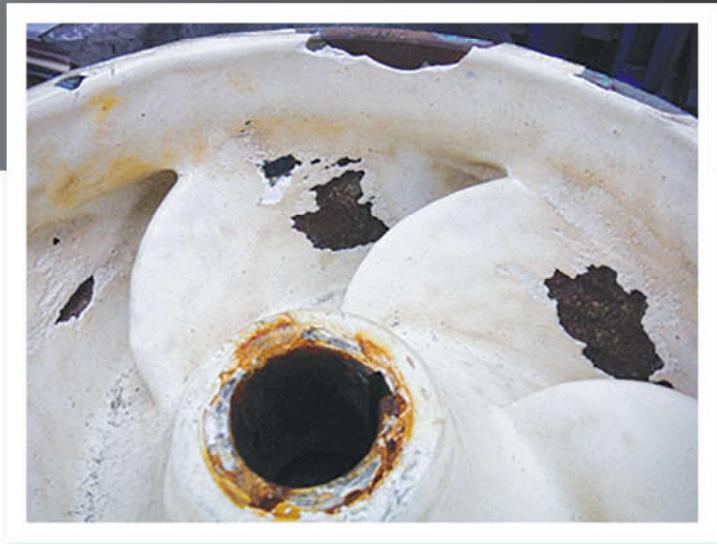
The above picture is an example of how quickly coatings fail on rotating impellers from the high fluid velocities!

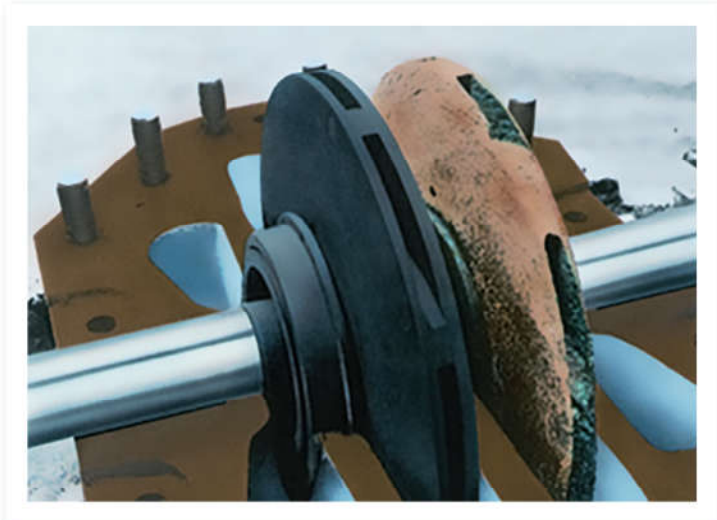
This two stage pump ran for two years in sea water service. The **SIMSITE®** Structural Composite Impeller is "Like New," whereas the coated bronze impeller has to be replaced.

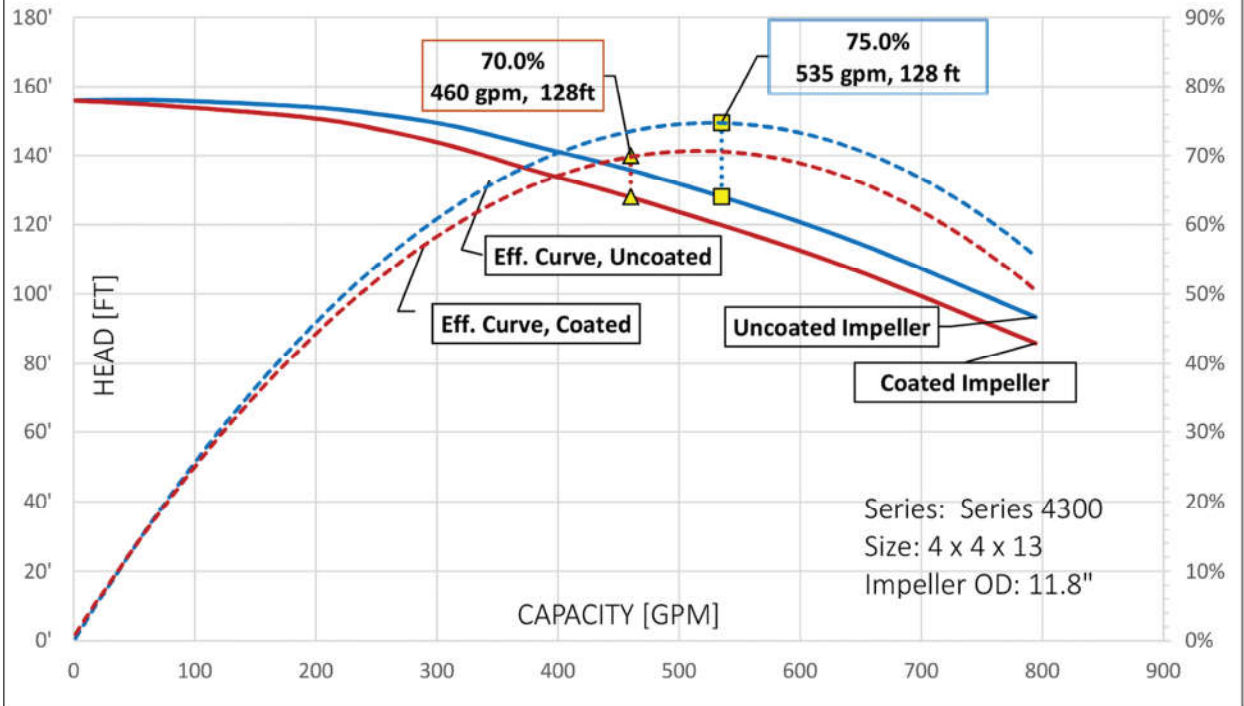
LOSS OF EFFICIENCY OF COATED IMPELLER V.S. UNCOATED IMPELLER

As you can see in Charts and Graph to the right, Coating the Metallic Impeller caused a narrowing of the impeller vane channels, which reduced the Operating Point to be reduced from 535 GPM to 460 GPM. The coating caused the operating point to be moved back on the HQ curve farther away from the Best Efficiency Point (BEP). As a result Pump Efficiency was also reduced by 5% from 74.8% to 70.0%. In order to pump the same amount of fluid, the pump with the coated impeller must work an additional 1,205 hours per year. The result is a total monetary loss of \$4,538.

Pump Performance Loss as a result of Coating Impeller

Uncoated	Coated	Losses
Pump performance - Time required to move 650,000 Gallons of water per day	Impeller OD (in)	11.8	11.8	
	Rotations Per Minute	1760	1760	
	Operating Point (GPM)	535	460	-75
	Head(Ft)	128	128	
	Efficiency (%)	75%	70.0%	-5%
	BHP(Hp)	23.1	21.2	-1.9
	Power Consumption (kW)	17.3	15.8	-1.4
	Time Required (Hrs/Year)	7,391	8,596	1,205

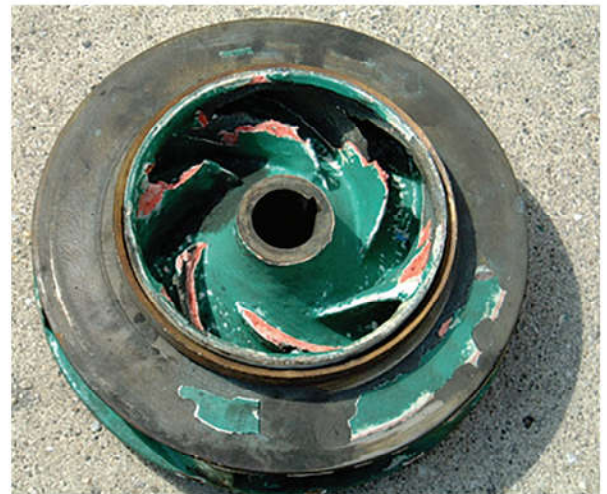
These two different types of Ceramic Coatings have come off both of these impellers in service allowing accelerated holes & damage to the metallic impellers rendering both types of impellers useless.

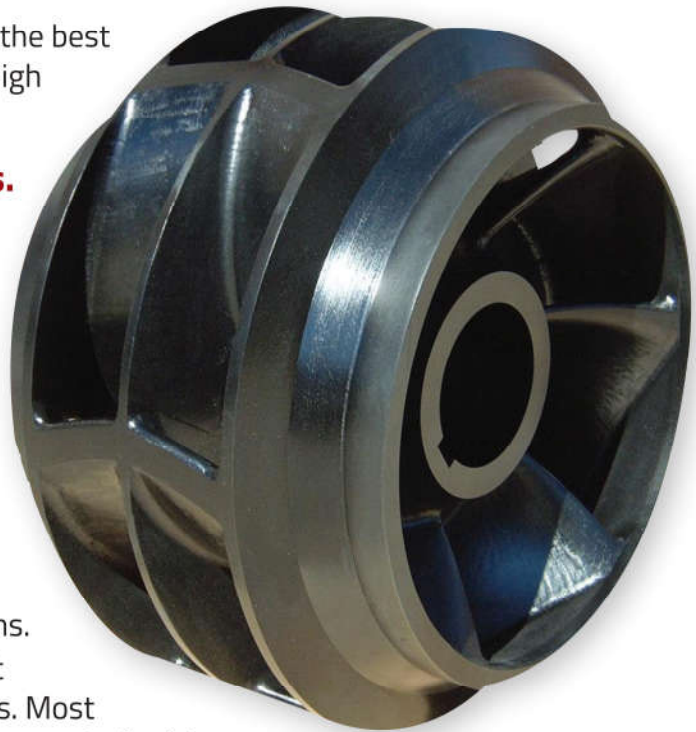
With the possible difficulties applying coatings and with a possibility of a limited lifetime, coatings may not be the best option when it comes to choosing your impellers. Composites do not need coatings and usually last much longer than coated metallic impellers in corrosive applications. Below you can see a **SIMSITE®** Structural Composite impeller that can last easily last 15 to 20 years in sea water service.

SIMSITE® Impellers are machined from solid blocks of **SIMSITE®** structural composite on 5-8 axis machining centers and therefore have inherent non-corrosive properties.
