Mystic Generating Station

14.38 x 9.00
Simsite[®] Impeller

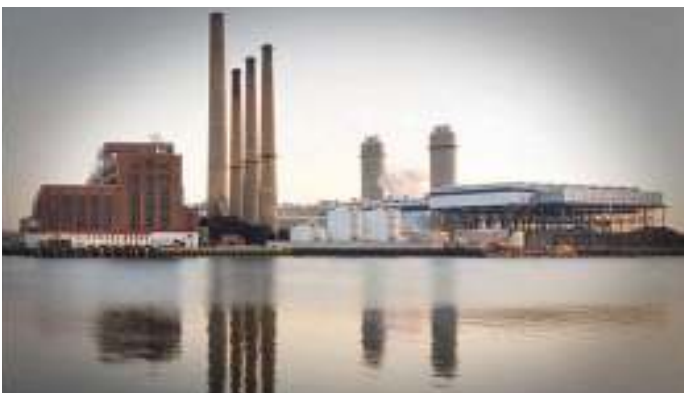
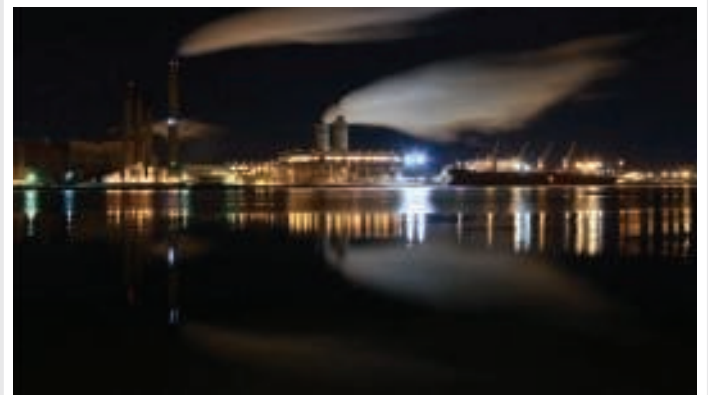
Pump performance degrading because of increased clearance between impeller and wear ring due to extreme wear from tidal water, wear rings and impellers show signs of extreme wear and reduced life span. Service life reduce anywhere from 6 to 14 months.

the Mystic Unit 6 South circulating water booster pump was opened and the Simsite[®] impeller was inspected. This pump had been running continuously in tidal water since the Simsite[®] impeller was installed approximately 16 months ago. The Simsite[®] impeller looked like the day it was installed. There was no evidence of corrosion/erosion or wear of any kind.
